**Culebra Ferryboat Cargo Ramp  
Repair/Reconstruction**  
Technical Note Assessment Existing  
Conditions  
Puerto Rico Ports Authority

November 25 2013

<b>Project:</b>	Culebra Ferryboat Terminal Cargo Ramp Repair/Reconstruction (AP-13-14-5-034)	<b>To:</b>	Autoridad de los Puertos
<b>Subject:</b>	Assessment Existing Cargo Ramp	<b>From:</b>	Arturo Santiago-Rivera
<b>Date:</b>	Nov 25, 2013	<b>cc:</b>	Flavio Silva, Romel Pedraza

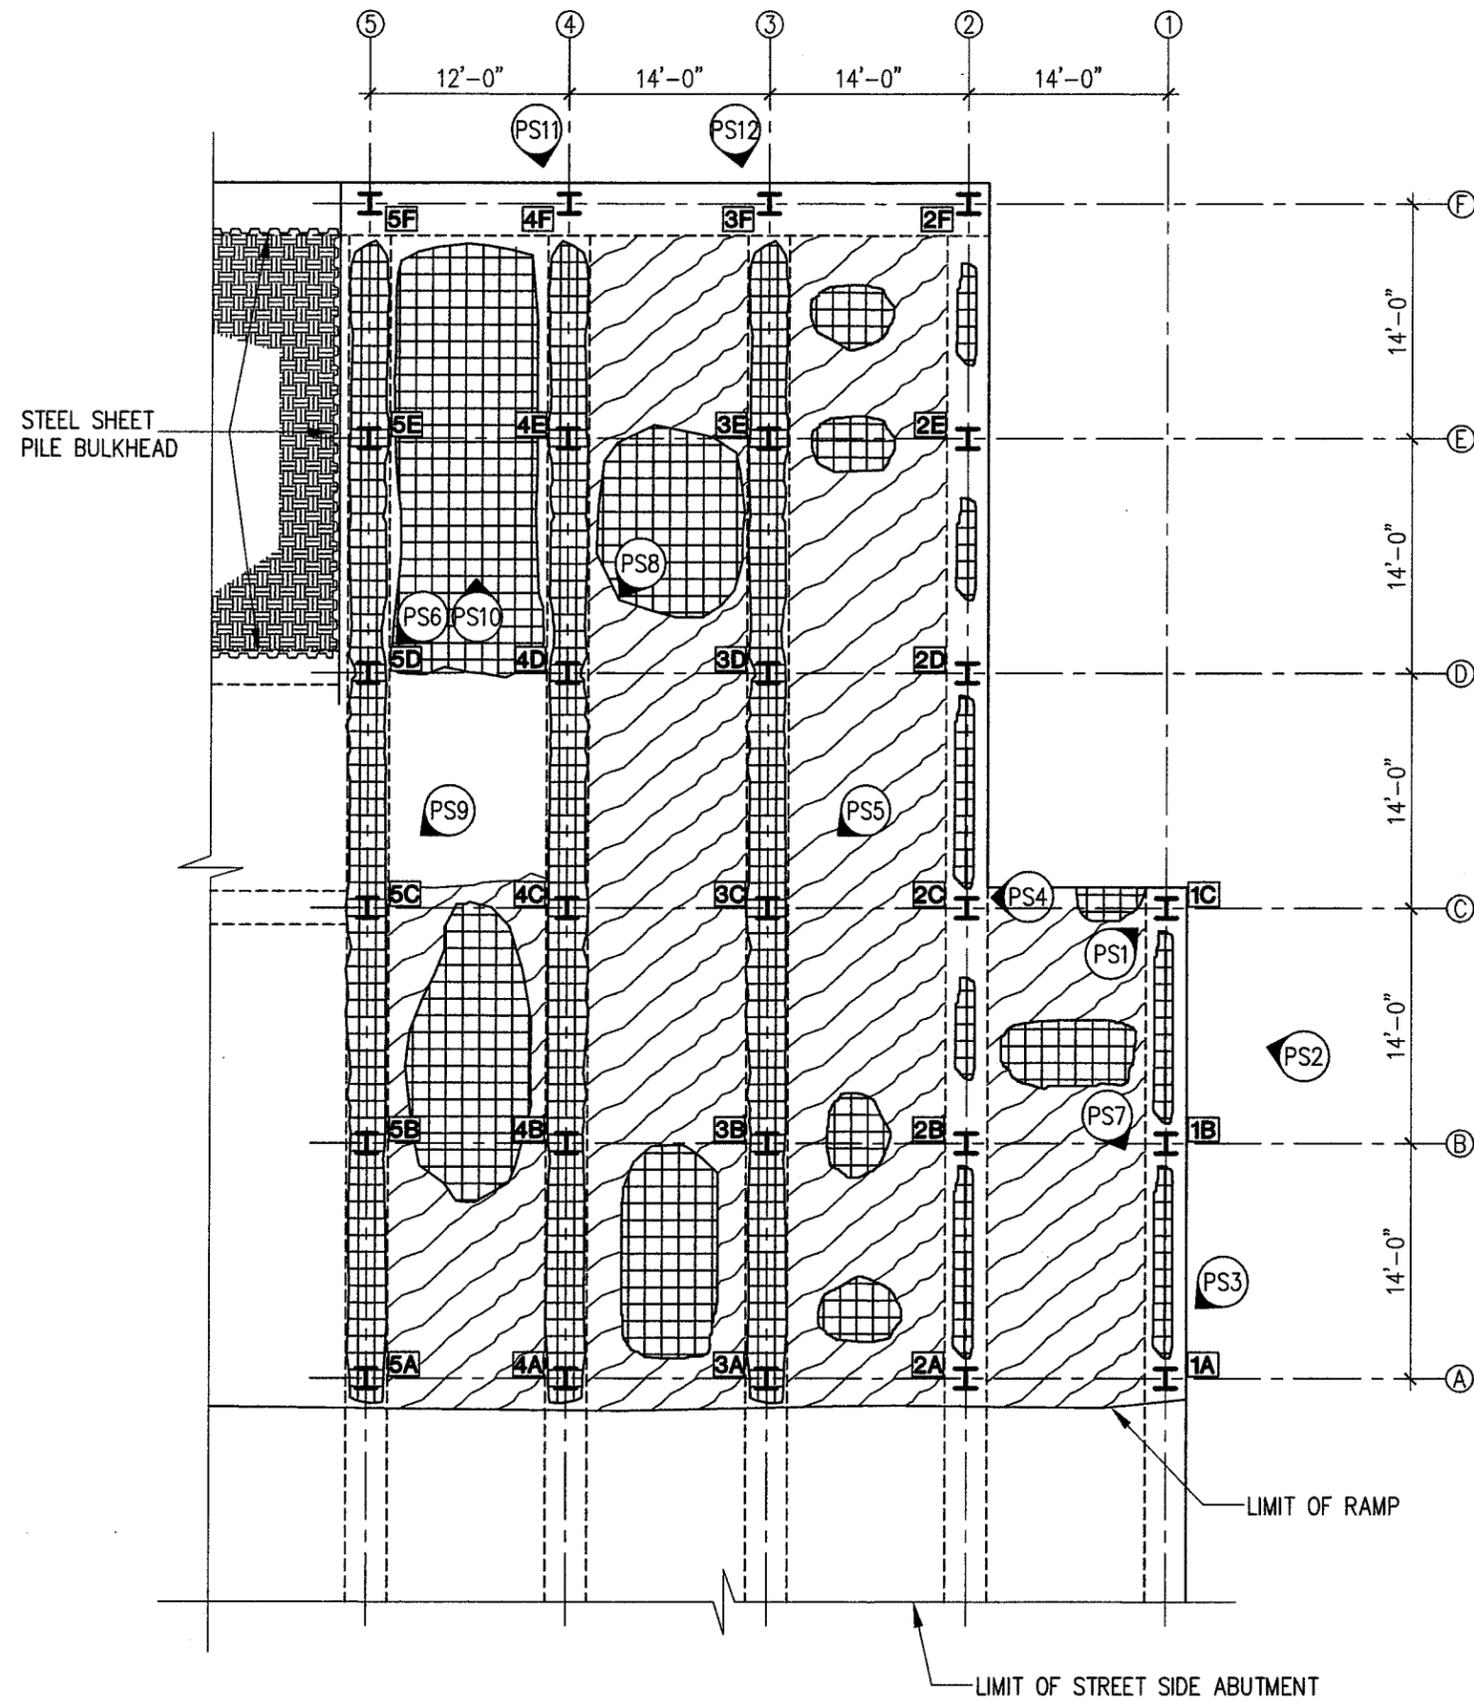
**CARGO RAMP UNDERSIDE EXISTING CONDITION**  
SCALE 3/16" = 1'-0"

- Concrete slab underside - The typical condition shows severe spalling of the concrete cover and corroded reinforcement. Other areas are showing imminent spalling as puffing of the cover can be observed. Please refer to the attached photographs.

- Concrete Beams - All five beams have severe spalling of the concrete cover and heavily corroded horizontal and transverse reinforcement. In many cases the main horizontal reinforcement is missing or separated from the concrete. The vertical reinforcement is broken in many cases, breaking continuity of this reinforcement with the bottom portion of the beam. Please refer to the attached photographs.

- Steel Piles - There are 27 piles in the support system. Piles are HP. 14 X 73. Piles typically show significant deterioration from the beam interface to the splash zone. Some piles have lost most of the web and/or flange material at the beam interface. Condition improves as pile gets closer the mud line level. Measurements made with an electronic underwater thickness gauge (Checkline TI-25 M) indicated flange thicknesses ranging from 0.25 inches to 0.45 inches. Web measurements were around 0.43 inches. Original thickness should be 0.51 inches for both areas.

The structure is considered unsuitable to perform the current operation due to the condition described above. Repairs must be performed immediately or the ramp will have to be closed and another method of loading and unloading cargo will need to be used. See appendix A for detailed ramp damaged areas and condition photos.

Per the assessment and visual inspection executed in November 2013, the condition of the slab and beams are considered beyond economical repairs because the difficulty and phasing time to complete will make the cost prohibitive. In addition, the quality of expected results would be difficult to attain and the durability could be limited. Demolition of the entire deck structure and replacement with a pre-cast system, similar to the structure of the passenger terminal deck, is the preferred alternative because it will ensure a durable solution for many years. In addition, the time to complete this option will be less than a repair/reconstruction option.

For the piles, the recommendation is to remove the portions of all piles to a depth of 3 feet to 4 feet below the mud line (assumed location of sound HP pile section) level with a new pile segment. With the appropriate connection the pile will essentially become a new member. Protection of the new pile segments with a fiberglass or PVC jacket system filled with epoxy grout and reinforces steel is required to insure durability of the piles.

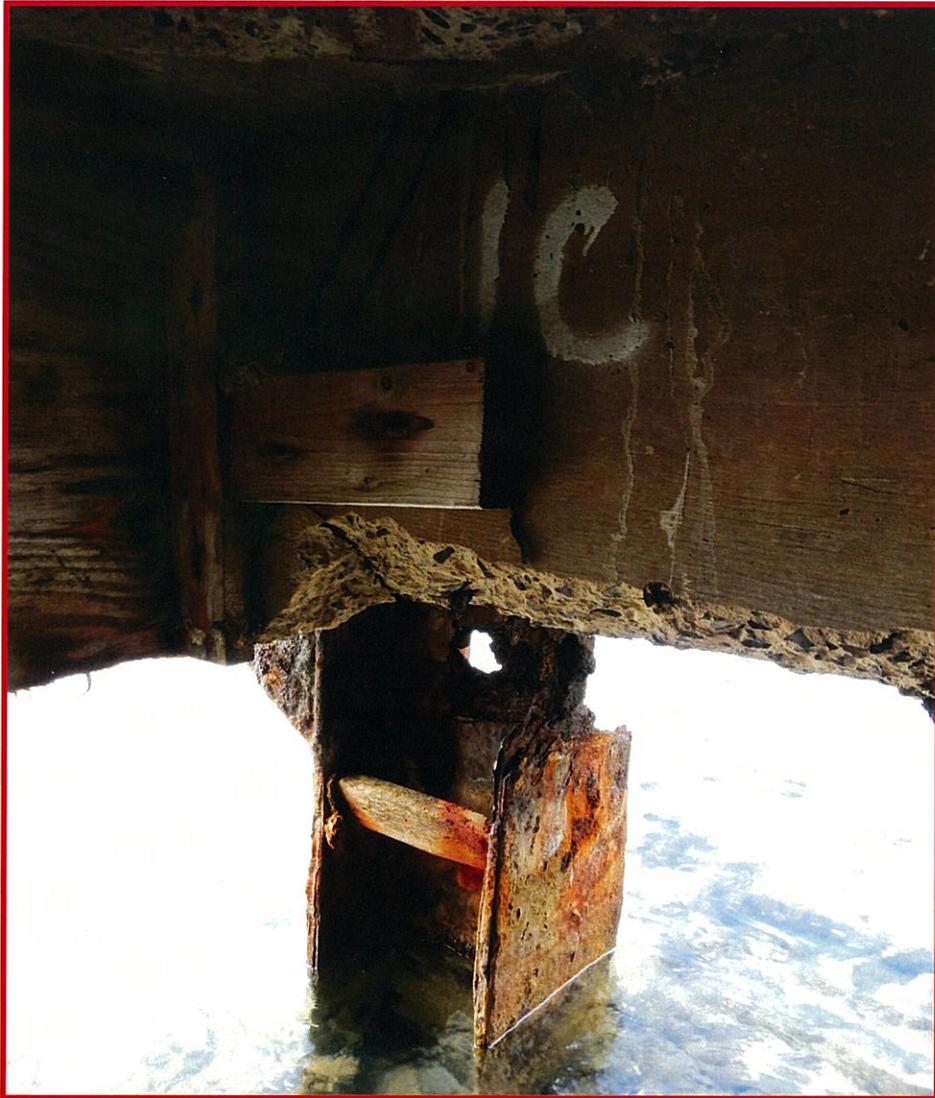
**HP PILE WITH SIGNIFICANT DAMAGE OF THE  
CROSS SECTION OF PILE 1C**

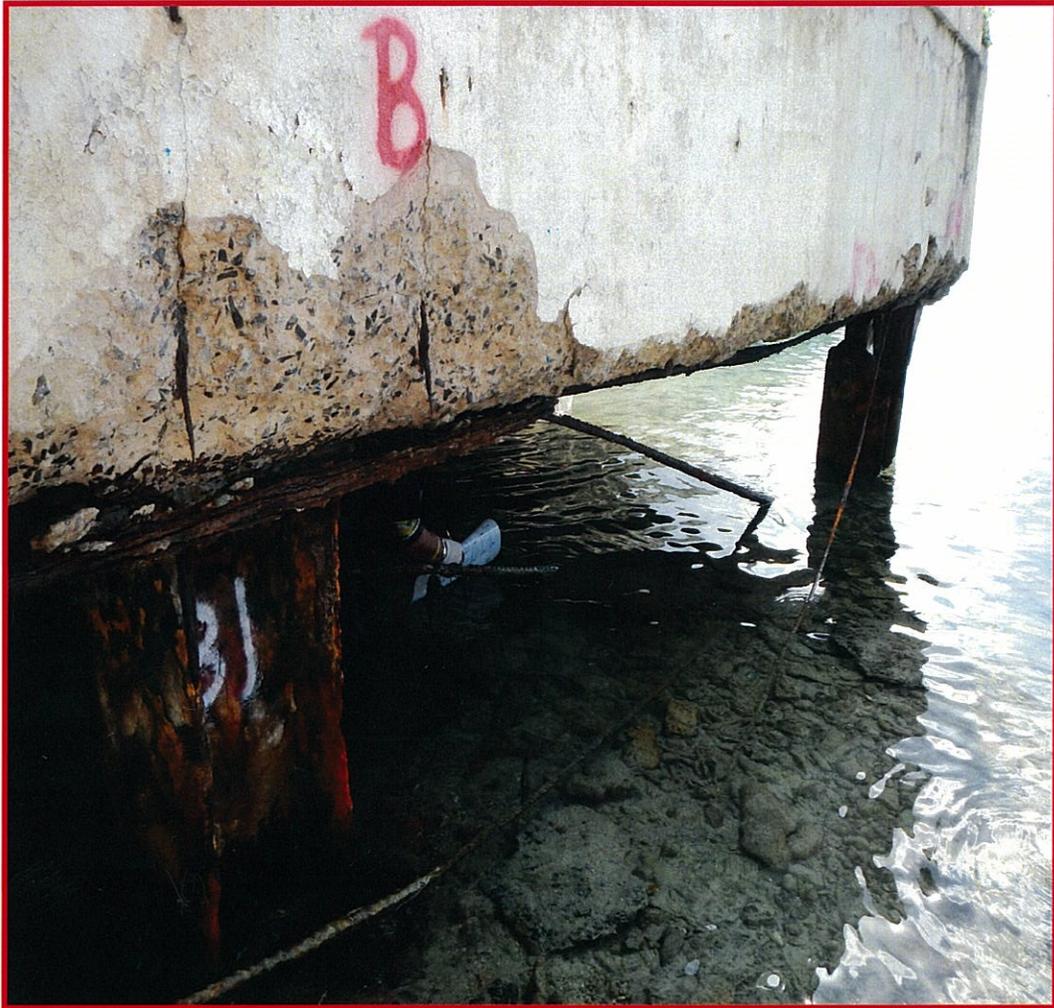
**SIDE VIEW OF BEAM AT AXIS 1**

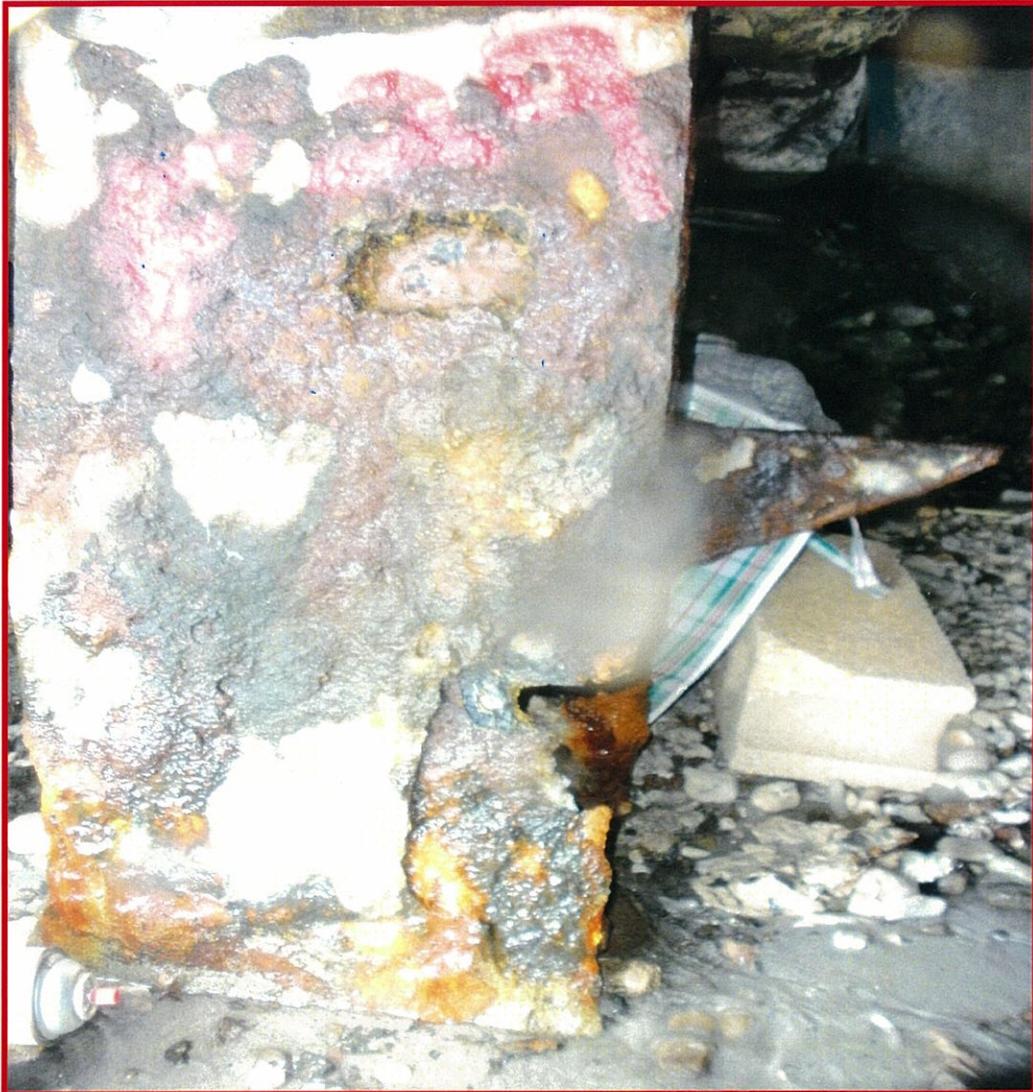
**CONDITION OF PILE AT LOCATION 1 A. NOTE CONDITION SIGNIFICANT  
REDUCTION OF FLANGE THICKNESS OF PILE AND HOLE**

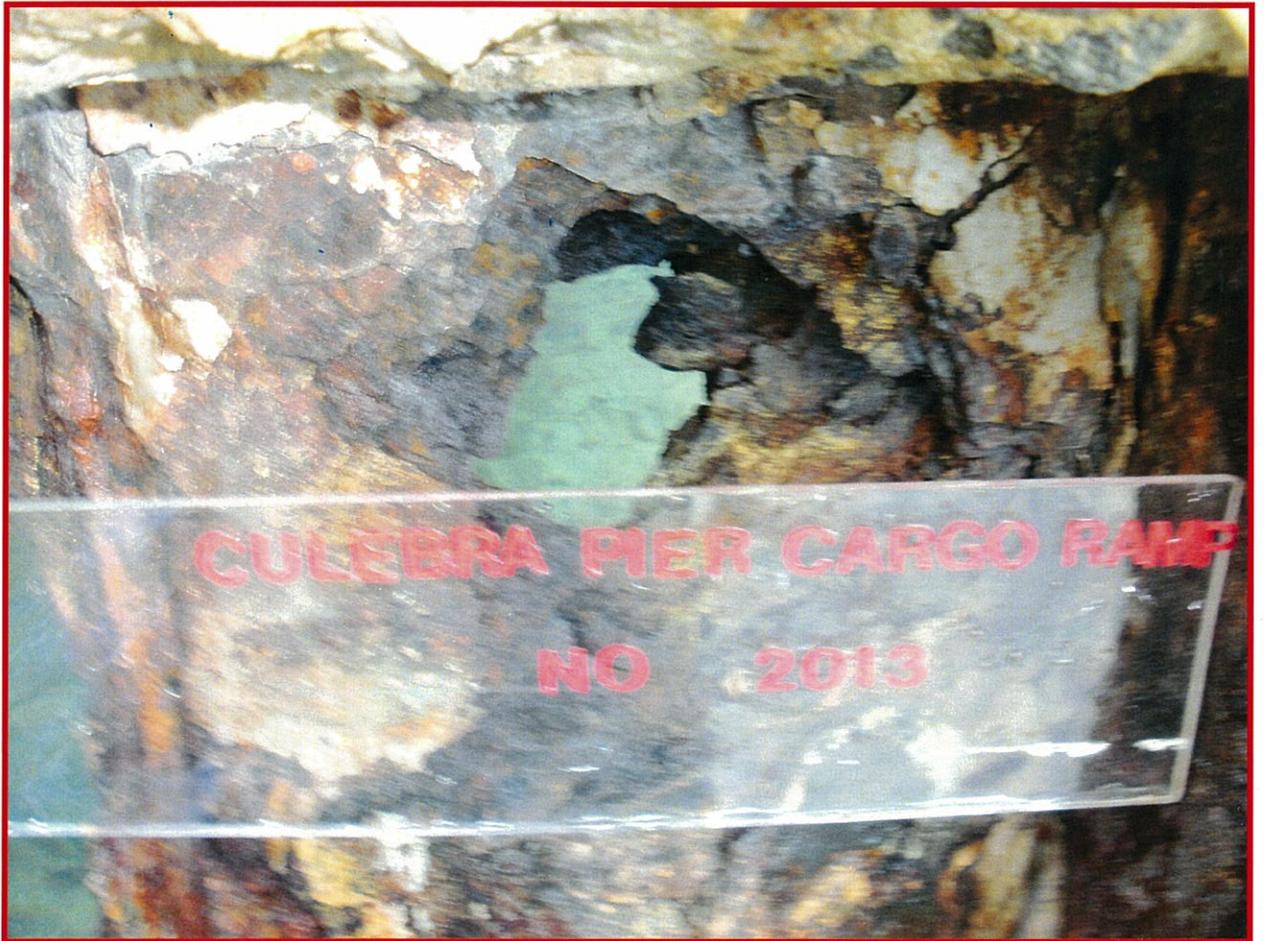
**CONDITION OF PILE AT LOCATION 2 C NOTE CONDITION  
SIGNIFICANT REDUCTION OF PILE WEB THICKNESS AND HOLE**

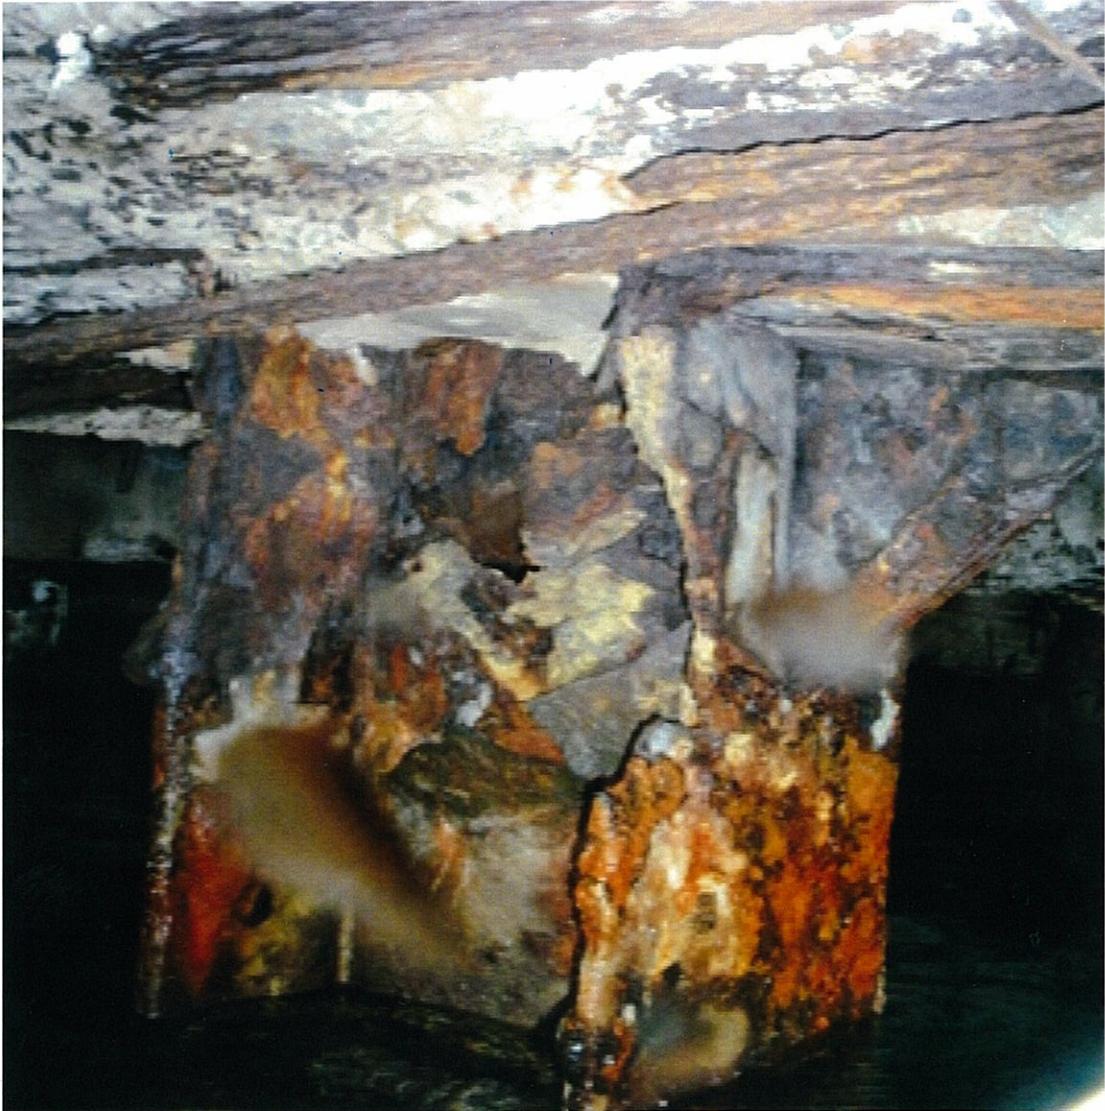
**VIEW OF PILE AT LOCATION 3 C.**

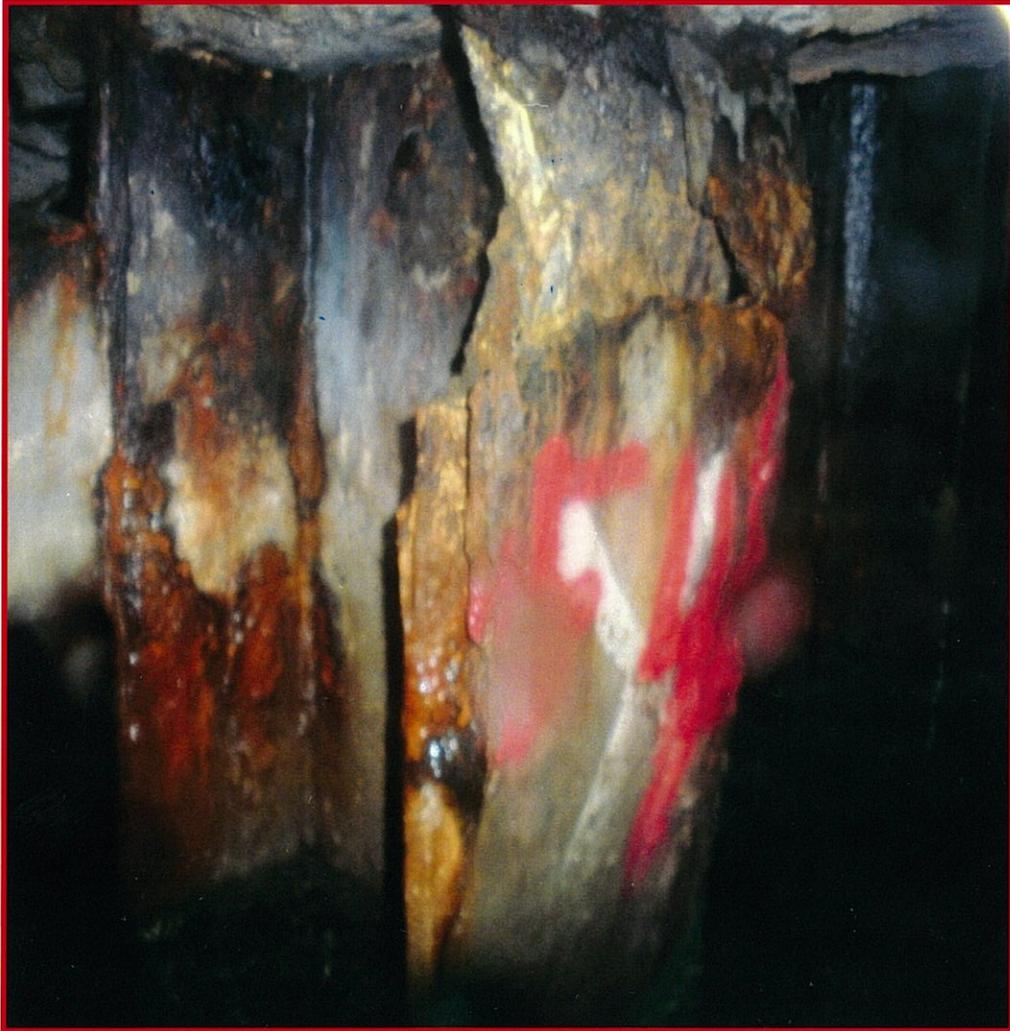
**VIEW OF PILE AT LOCATION 5 D.**

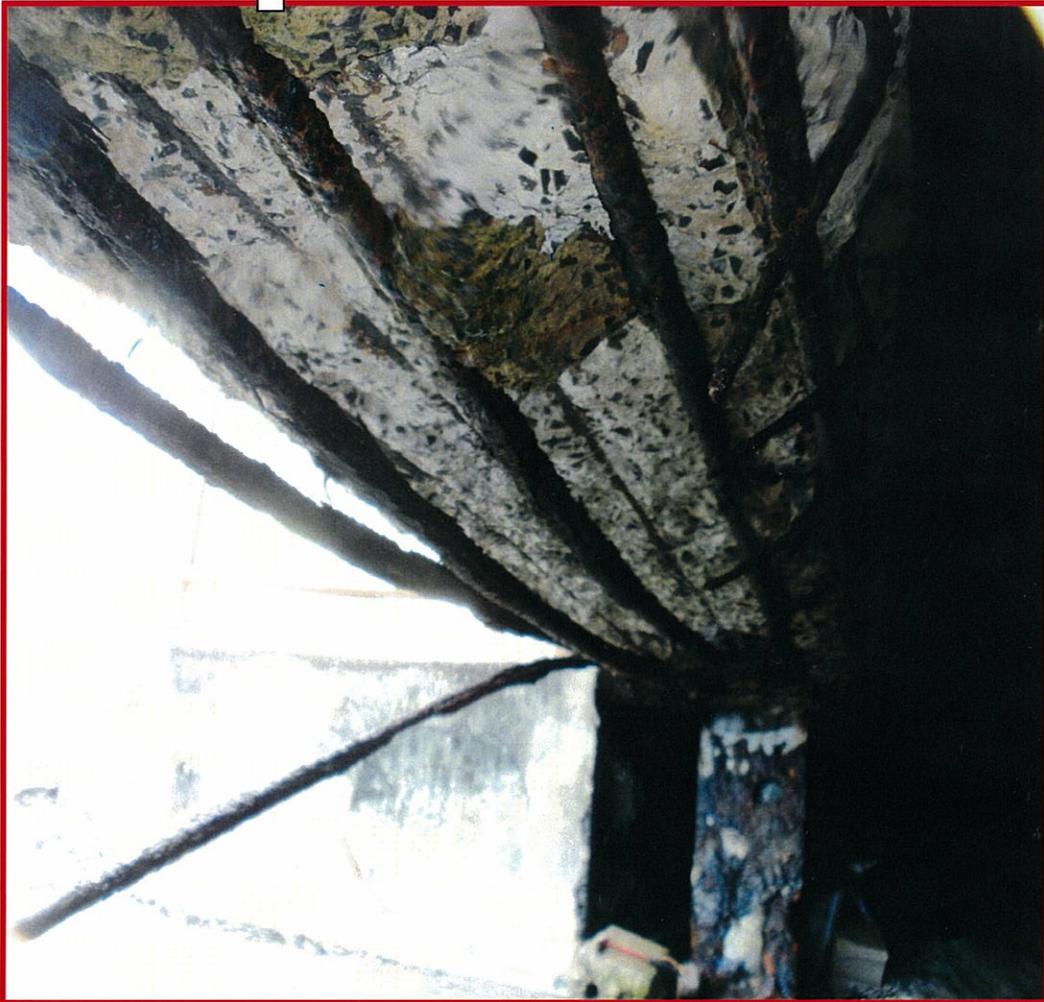
**BEAM CONDITION WITH CONCRETE COVER SPALLING  
AND REINFORCEMENT WITH SIGNIFICANT DAMAGE.  
BEAM IS AXIS 1 AND PILE BEYOND IS 1A**

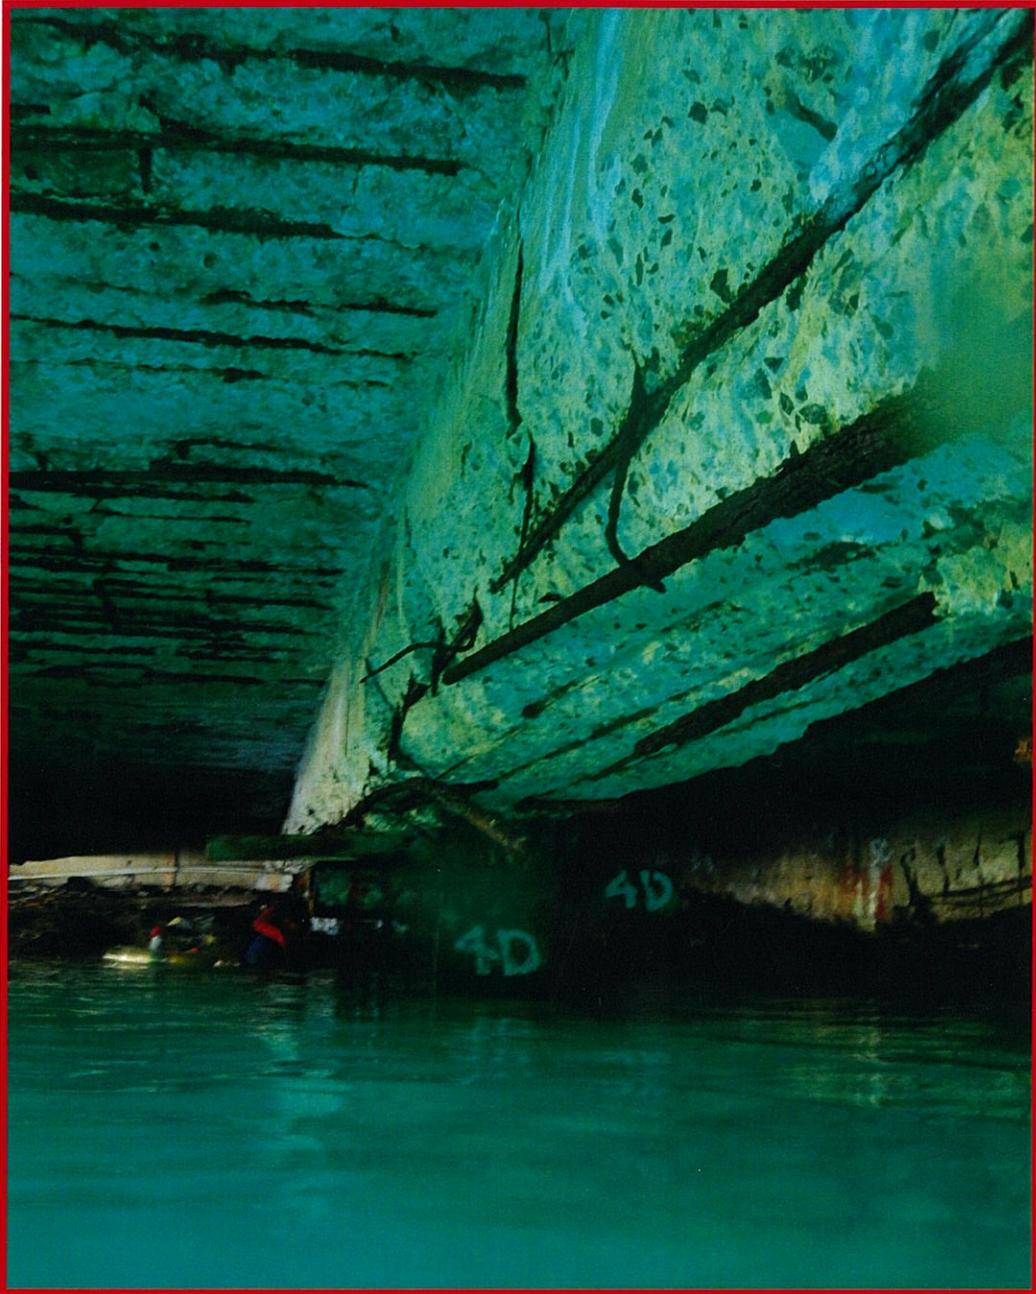
**VIEW OF BEAM AT AXIS 4**

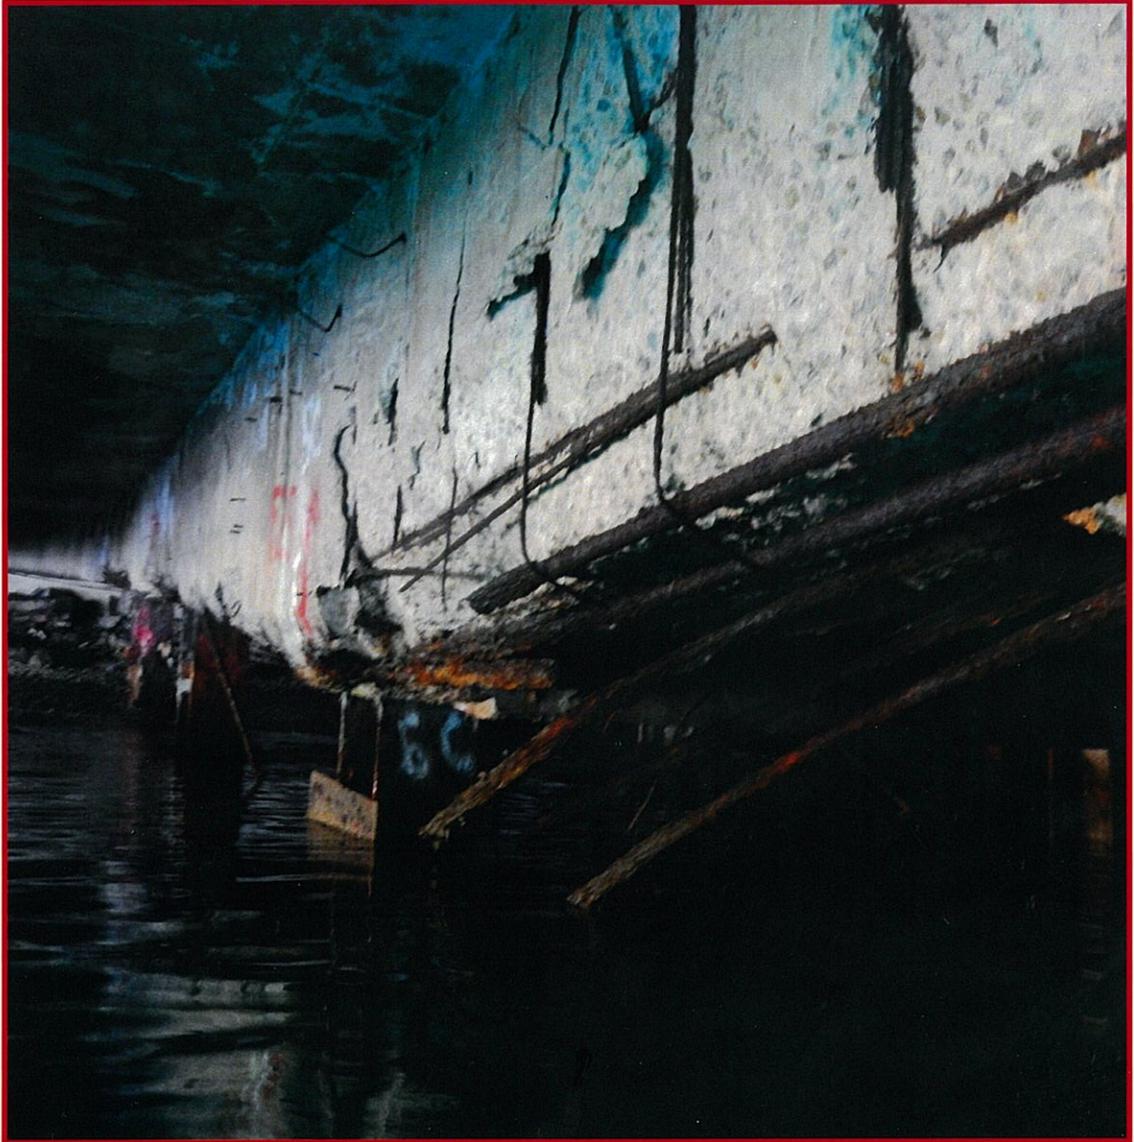
**VIEW OF BEAM AT AXIS 5**

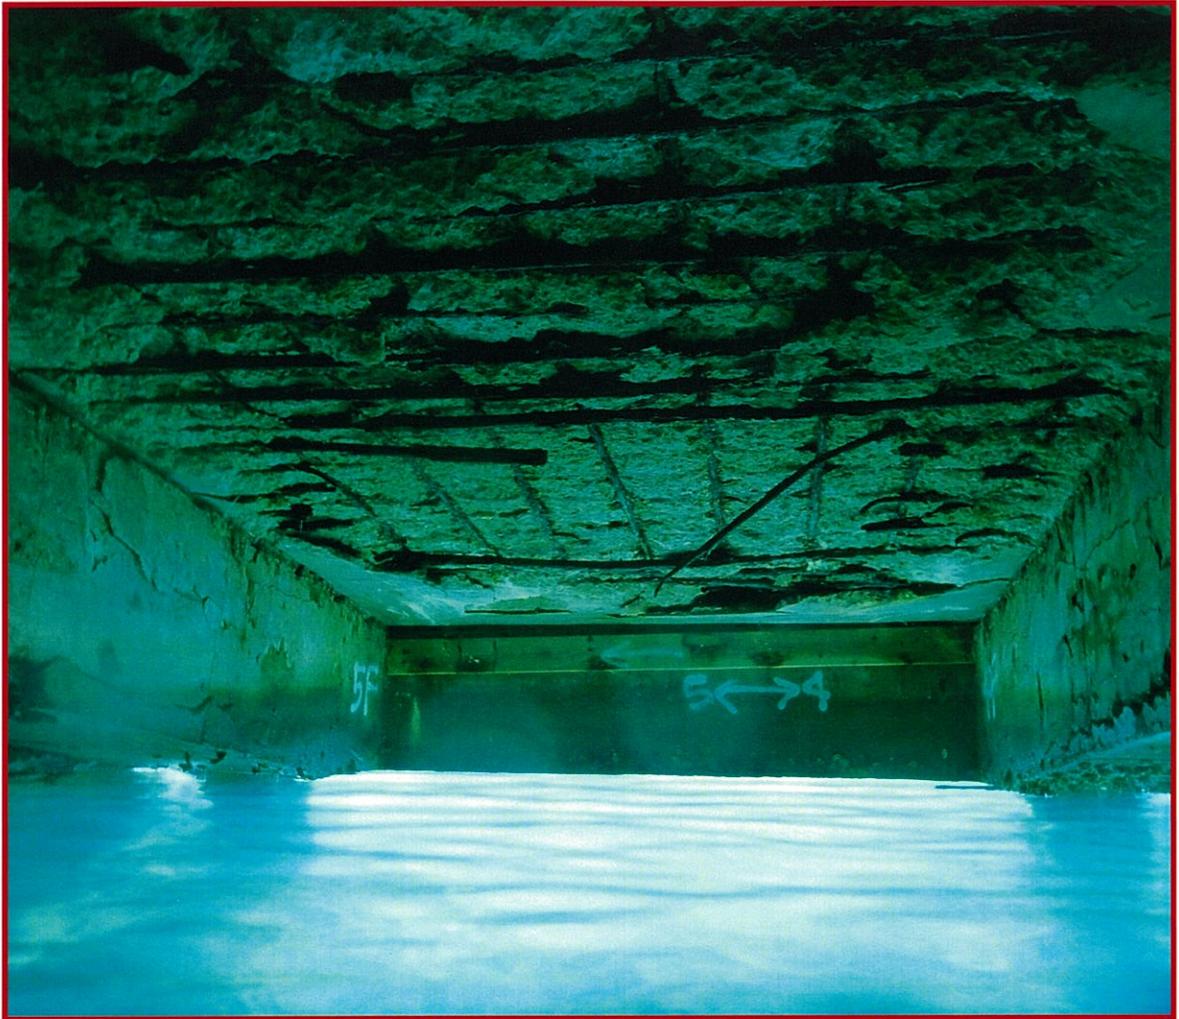
**VIEW OF DECK CONDITION BETWEEN AXES 4 AND 5  
(LOOKING TOWARD THE WATER SIDE)**

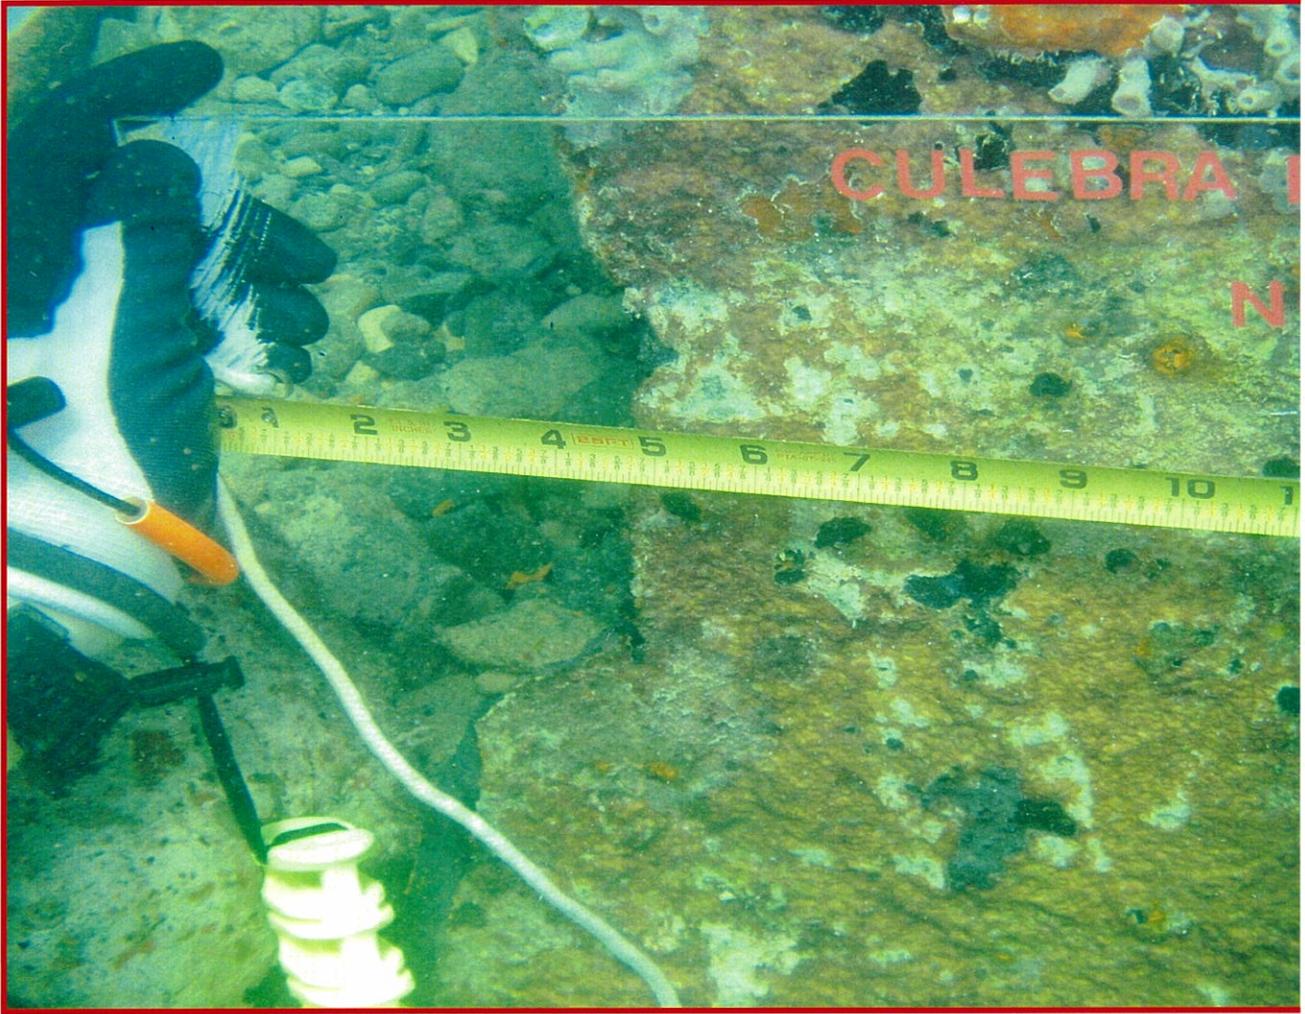
**VIEW OF PILE 4 F AT THE MUDLINE LEVEL  
NOTE REDUCTION OF FLANGE PLATE WIDTH**

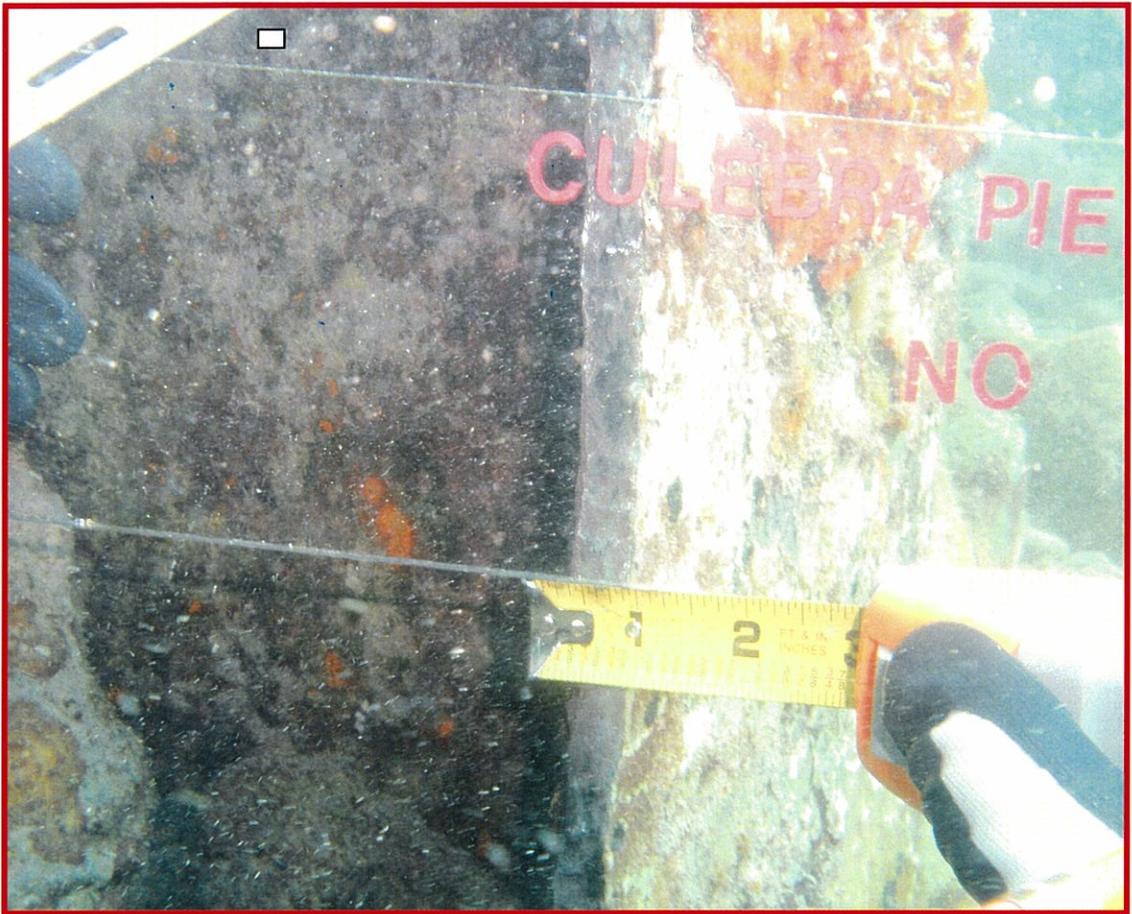
**VIEW OF PILE 3 F AT THE MUDLINE LEVEL  
(THICKNESS OF FLANGES BEING MEASURED)**
